Manhole Inspection Summary

Manhole # S19GG_008MH

Insp Date: **6/13/07 9:38 AM**

Location Address: **1600 PULASKI ST**

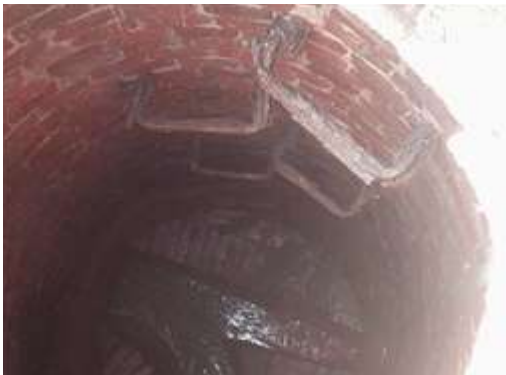
Defect 1

Count: **5** Missing: **1** ☒ **Corroded**

CORRODED STEPS AND MISSING

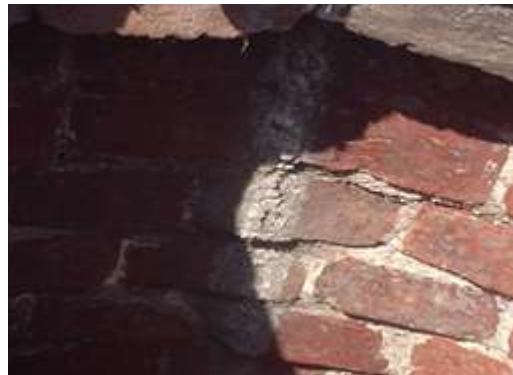
Defect 3

Infiltration: ☐ None ☒ **Joint** ☐ Cracks ☐ Mortar ☐ Roots ☐ Wall

INFILTRATION OF CHIMNEY

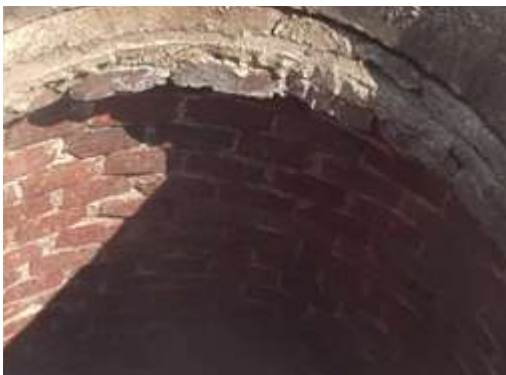
Defect 2

Condition: ☐ Sound ☐ Cracked ☐ Root Intrusion ☐ Loose Brick ☒ **Deteriorated**

DETERIORATION OF CHIMNEY

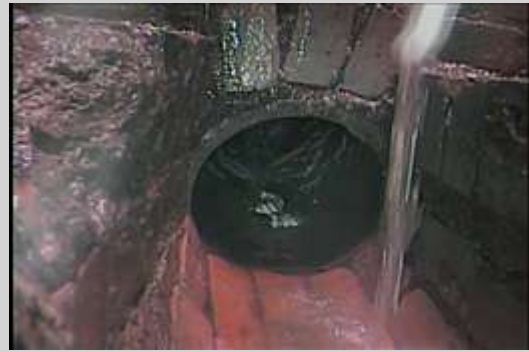
Drop In @ 6 O'Clock

Drop Condition: **Clogged**
